# Access Compliance Report Public Rights-of-Way (Curb Ramps)

| Main Street: GILBERT_ST | | Cross Street: CHANTICLEER_RD | | Location: | NE |
| ADA ID: RPAT220203094812 | Ramp Type: Type 4 - Parallel | Initial Pass/Fail: Pass | Overall Compliance: No | Severity Score: | 0 |

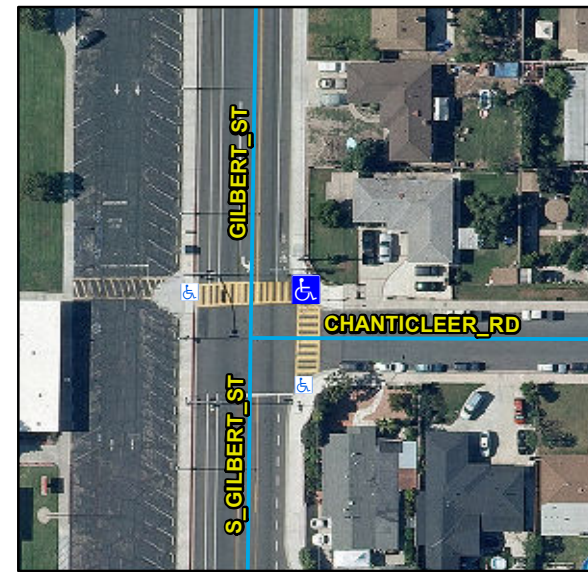
| Compliance | Description | Data | Compliance | Description | Data |
|---|---|---|---|---|---|
| Yes | Gutter Ponding | No | No | Curb Slope | 12.3 |

**Remove & Replace Curb Slope. Utility Present.**

**R304.2.2, STD 1115**

Total Cost: \$ 252
