# Access Compliance Report Public Rights-of-Way (Curb Ramps)

| Main Street: CHANTICLEER_RD | | Cross Street: S_GILBERT_ST | | Location: | SE |
| ADA ID: RPAT220203095744 | Ramp Type: Type 4 - Parallel | Initial Pass/Fail: Fail | Overall Compliance: No | Severity Score: | 30 |

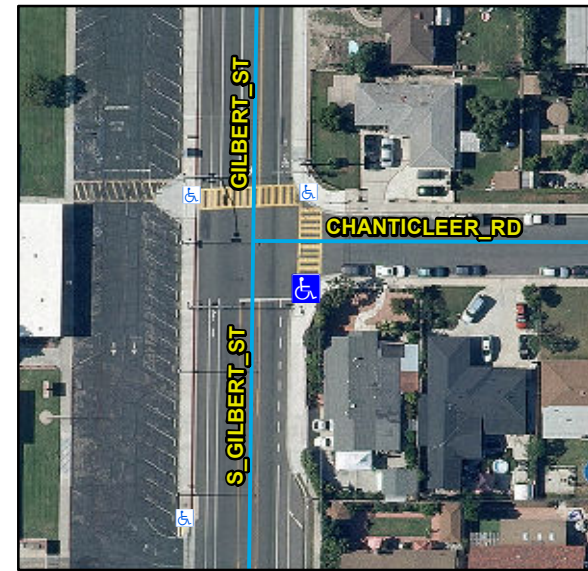
| Compliance | Description | Data | Compliance | Description | Data |
|---|---|---|---|---|---|
| No | Ramp Cross Slope LT (%) | 7.1 | No | Ramp Cross Slope RT (%) | 7.4 |

Possible Solutions:

Remove & Replace Entire Ramp.

R304.5.3, STD 1115

Total Cost: \$ 2000
