# Access Compliance Report Public Rights-of-Way (Curb Ramps)

Main Street: N/A Cross Street: GILBERT\_ST Location: W

ADA ID: RPAT220203100319 Ramp Type: Type 7 - Directional 2 Initial Pass/Fail: Fail Overall Compliance: No Severity Score: 30

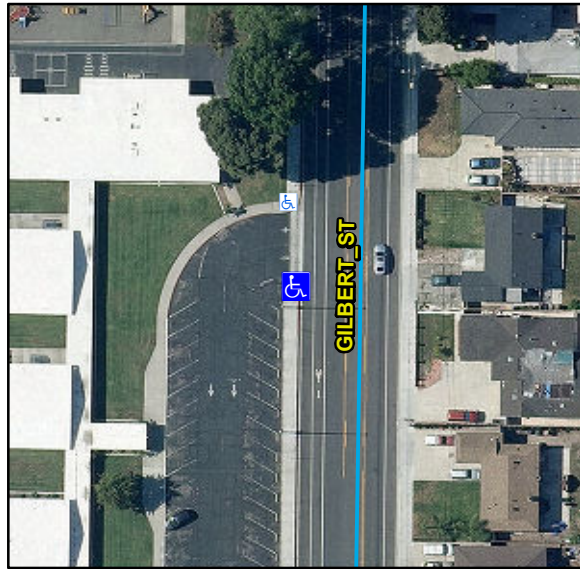
| Compliance | Description | Data | Compliance | Description | Data |
|---|---|---|---|---|---|
| No | Ramp Run Slope (%) | 10.7 | N/A | Flare Slope LT (%) | N/A |
| No | Gutter Lip Height (in) | 1 | | Road Run Slope (%) | N/A |

Remove & Replace Entire Ramp. Grind Gutter Lip.

R304.5.1, R304.2.2, R304.3.2, R304.5.3, R302.7.2, STD 1115

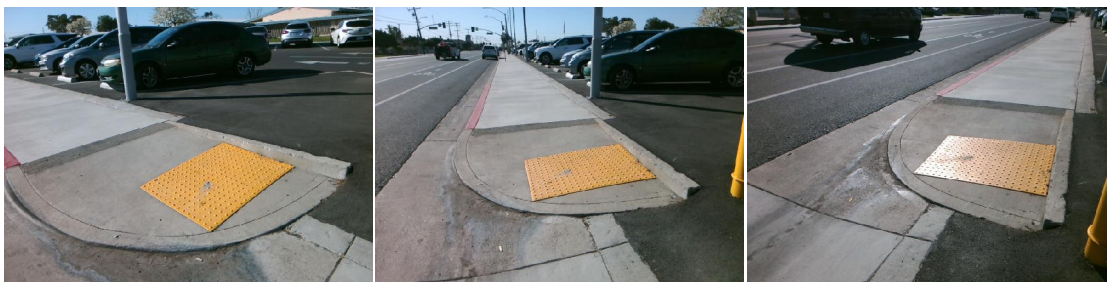
| Compliance | Description | Data | Compliance | Description | Data |
|---|---|---|---|---|---|
| Yes | Overall Surface Condition | Acceptable | Yes | Perp Joint Present | Yes |
| | Cross Gutter Present? | Yes | | Spandrel Present? | Yes |
| | Replace Cross Gutter? | No | | Replace Spandrel? | No |
