# Access Compliance Report Public Rights-of-Way (Curb Ramps)

Main Street: N/A Cross Street: GILBERT\_ST Location: NW

ADA ID: RPAT220203100822 Ramp Type: Type 3 - Combination 1 Initial Pass/Fail: Fail Overall Compliance: No Severity Score: 32

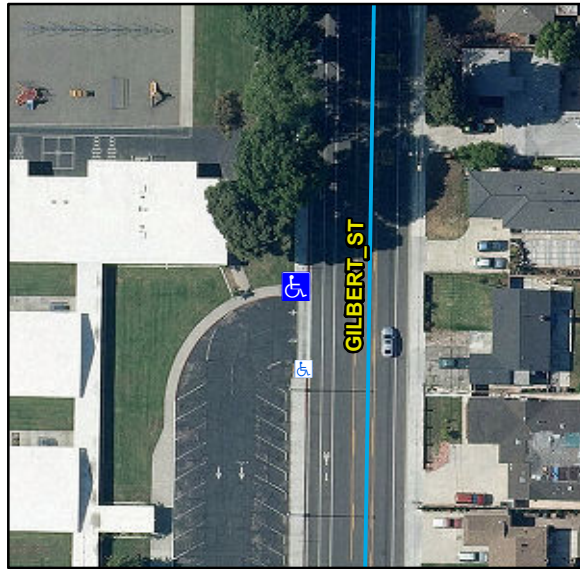
| Compliance | Description | Data | Compliance | Description | Data |
|---|---|---|---|---|---|
| No | Ramp Run Slope LT (%) | 13 | No | Ramp Run Slope RT (%) | 10.7 |
| No | Ramp Cross Slope LT (%) | 4.3 | No | Ramp Cross Slope RT (%) | 4.5 |
| No | Ramp Cross Slope (%) | 4.9 | N/A | Flare Traversable LT | N/A |

Remove & Replace Entire Ramp.

R304.2.2, R304.5.3, R304.3.2, STD 1115
