# Access Compliance Report Public Rights-of-Way (Curb Ramps)

| Main Street: GILBERT_ST | | Cross Street: GUINIDA_LN | | Location: | NE |
| ADA ID: RPAT220203101736 | Ramp Type: Type 4 - Parallel | Initial Pass/Fail: Pass | Overall Compliance: No | Severity Score: | 0 |

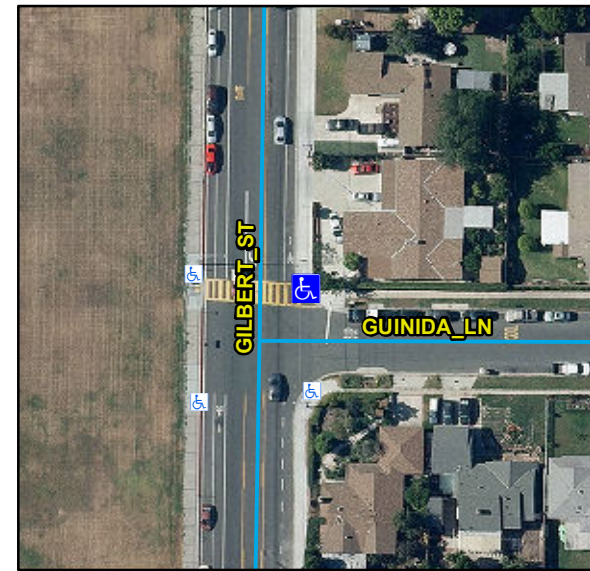
| Compliance | Description | Data | Compliance | Description | Data |
|---|---|---|---|---|---|
| No | Gutter Ponding | Yes | No | Curb Slope | 9.9 |
| Yes | Gutter Run Slope (%) | 5 | | Road Cross Slope (%) | 5.7 |

**Remove & Replace Curb Slope.**

**R304.2.2, R302.7, STD 1115**

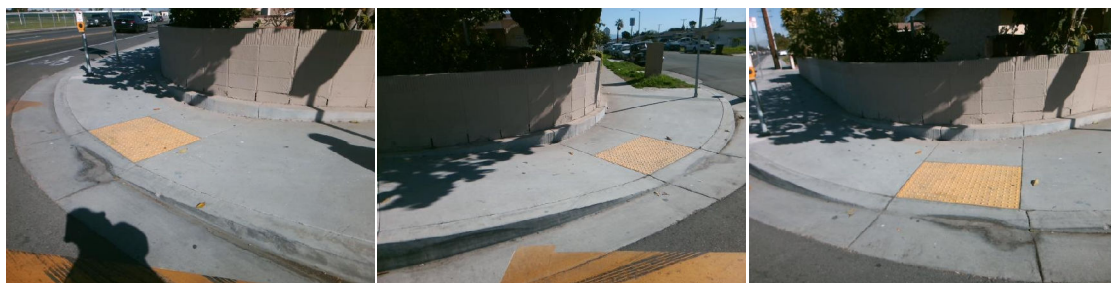
| Compliance | Description | Data | Compliance | Description | Data |
| N/A | Ramp Length LT (in) | 108 | N/A | Ramp Length RT (in) | 119 |
| Yes | Ramp Width LT (in) | 70 | Yes | Ramp Width RT (in) | 78 |
| Yes | Ramp Run Slope LT (%) | 7 | Yes | Ramp Run Slope RT (%) | 5.9 |
| Yes | Ramp Cross Slope LT (%) | 0.3 | Yes | Ramp Cross Slope RT (%) | 0.8 |

Possible Solutions:
