# Access Compliance Report Public Rights-of-Way (Curb Ramps)

Main Street: FLORIN\_LN Cross Street: GUINIDA\_LN Location: NE

ADA ID: RPAT220203102931 Ramp Type: Type 4 - Parallel Initial Pass/Fail: Fail Overall Compliance: No Severity Score: 19

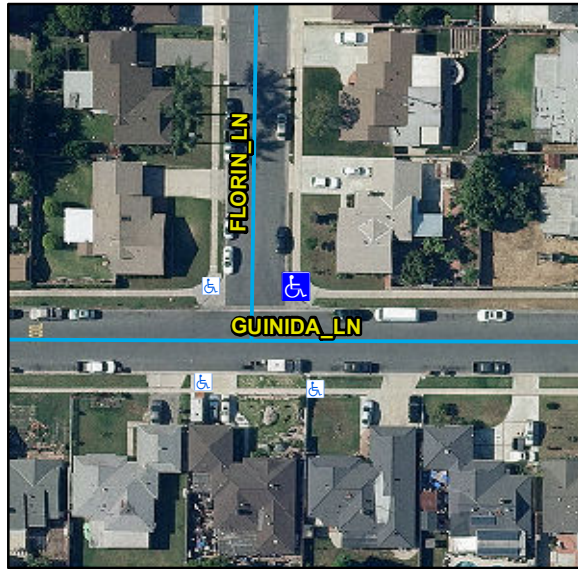
| Compliance | Description | Data | Compliance | Description | Data |
|---|---|---|---|---|---|
| No | Ramp Width LT (in) | 45 | Yes | Ramp Width RT (in) | 52 |
| No | Ramp Cross Slope LT (%) | 6.2 | No | Ramp Cross Slope RT (%) | 3.1 |

**Remove & Replace Curb Ramp With Two New Directional Ramps or Equivalent.**

**R304.5.1, R304.5.3, STD 1115**

\$ 4000
