# Access Compliance Report Public Rights-of-Way (Curb Ramps)

| Main Street: FARNHAM_LN | | Cross Street: MILNEBURG_ST | | Location: | SE |
| ADA ID: RPAT220203105047 | Ramp Type: Type 4 - Parallel | Initial Pass/Fail: Fail | Overall Compliance: No | Severity Score: | 5 |

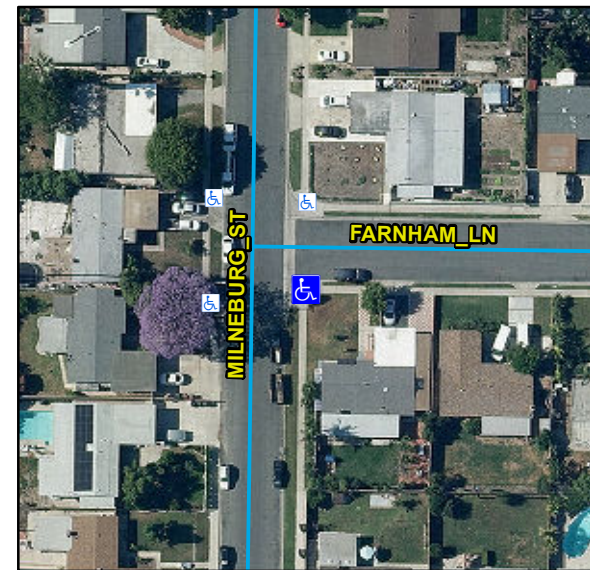
| Compliance | Description | Data | Compliance | Description | Data |
|---|---|---|---|---|---|
| No | Ramp Width LT (in) | 43 | No | Ramp Width RT (in) | 44 |
| No | Ramp Cross Slope LT (%) | 3.4 | No | Ramp Cross Slope RT (%) | 4 |

**Remove & Replace Curb Ramp With Two New Directional Ramps or Equivalent.**

**R304.5.1, R304.5.3, STD 1115**

Total Cost: \$ 4000

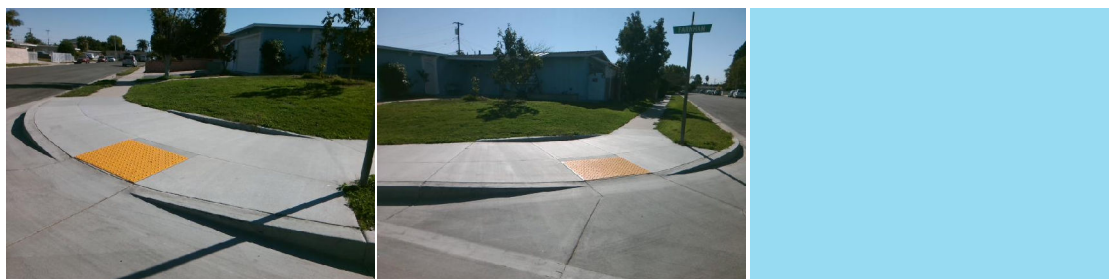
| Compliance | Description | Data | Compliance | Description | Data |
|---|---|---|---|---|---|
| N/A | Ramp Length LT (in) | 84 | N/A | Ramp Length RT (in) | 84 |
| Yes | Ramp Run Slope LT (%) | 7.2 | Yes | Ramp Run Slope RT (%) | 4.9 |
