# Access Compliance Report Public Rights-of-Way (Curb Ramps)

Main Street: MILNEBURG\_ST Cross Street: FARNHAM\_LN Location: NE

ADA ID: RPAT220203105436 Ramp Type: Type 4 - Parallel Initial Pass/Fail: Fail Overall Compliance: No Severity Score: 5

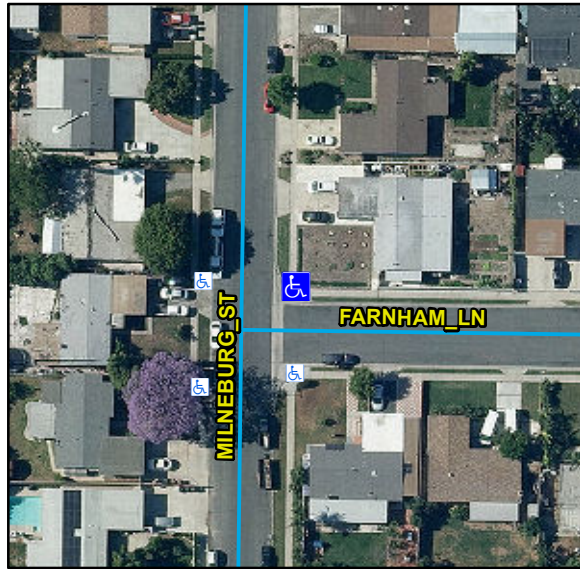
| Compliance | Description | Data | Compliance | Description | Data |
|---|---|---|---|---|---|
| No | Ramp Width LT (in) | 42 | No | Ramp Width RT (in) | 41 |
| No | Ramp Cross Slope LT (%) | 3.6 | No | Ramp Cross Slope RT (%) | 4.3 |

**Remove & Replace Curb Ramp With Two New Directional Ramps or Equivalent.**

**R304.5.1, R304.5.3, STD 1115**
