# Access Compliance Report

## Public Rights-of-Way

### (Curb Ramps)

Main Street: PERDIDO\_ST Cross Street: GUINIDA\_LN Location: SW

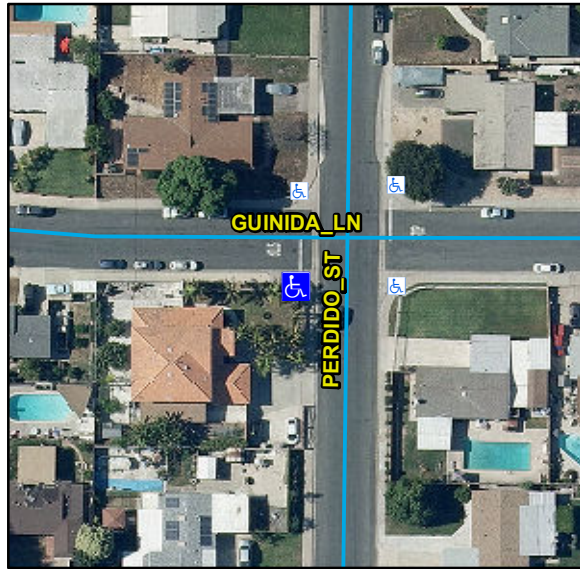
ADA ID: RPAT220203111006 Ramp Type: Type 4 - Parallel Initial Pass/Fail: Pass Overall Compliance: Yes Severity Score: 0

Possible Solutions:

N/A
