# Access Compliance Report

## Public Rights-of-Way

### (Curb Ramps)

Main Street: GRAVIER\_ST Cross Street: GUINIDA\_LN Location: NE

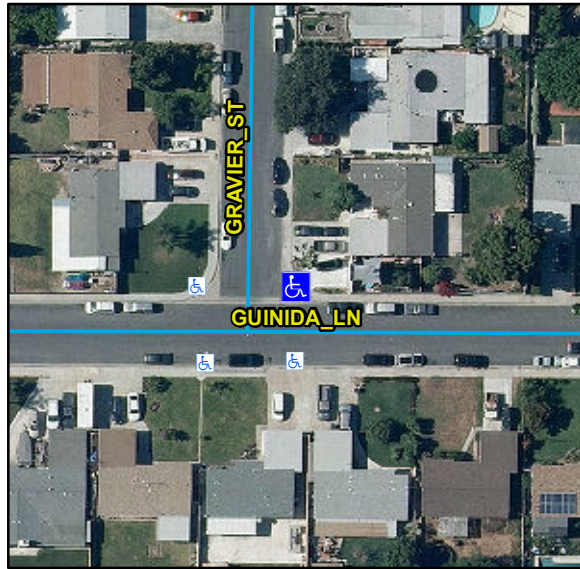
ADA ID: RPAT220203125328 Ramp Type: Type 4 - Parallel Initial Pass/Fail: Pass Overall Compliance: Yes Severity Score: 0

Possible Solutions:

N/A
