# Access Compliance Report Public Rights-of-Way (Curb Ramps)

Main Street: CERRITOS\_AVE Cross Street: PERDIDO\_ST Location: NW

ADA ID: RPAT220203132119 Ramp Type: Type 4 - Parallel Initial Pass/Fail: Pass Overall Compliance: No Severity Score: 6

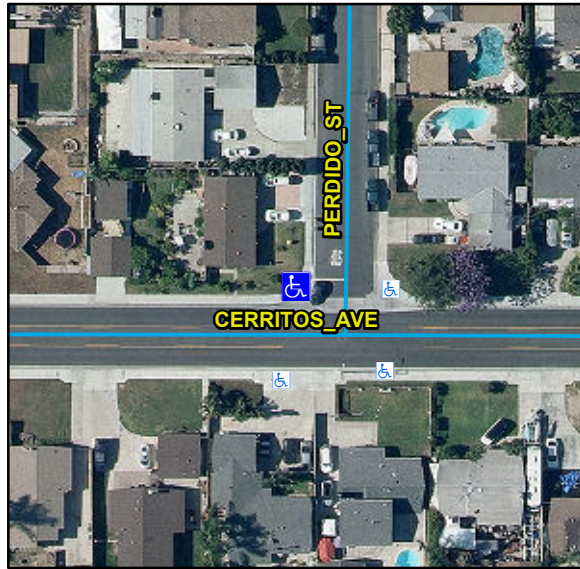
| Compliance | Description | Data | Compliance | Description | Data |
|---|---|---|---|---|---|
| No | Ramp Cross Slope LT (%) | 2.1 | Yes | Ramp Cross Slope RT (%) | 1.9 |
| Yes | Gutter Ponding | No | No | Curb Slope | 9 |
| No | Gutter Run Slope (%) | 8.4 | | Road Cross Slope (%) | N/A |

Remove & Replace Curb Slope. Remove & Replace Sidewalk. Remove & Replace Gutter.

R304.2.2, R304.5.3, R304.5.4, STD 1115

Total Cost: \$ 882

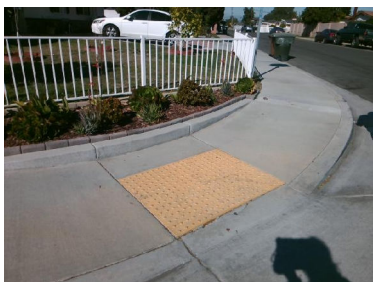
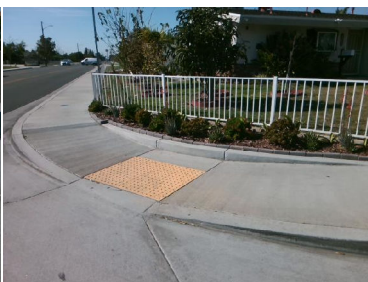
| Compliance | Description | Data | Compliance | Description | Data |
|---|---|---|---|---|---|
| Yes | Overall Surface Condition | Acceptable | | | |
