# Access Compliance Report Public Rights-of-Way (Curb Ramps)

Main Street: PERDIDO\_ST Cross Street: CERRITOS\_AVE Location: NE

ADA ID: RPAT220203132442 Ramp Type: Type 4 - Parallel Initial Pass/Fail: Pass Overall Compliance: No Severity Score: 0

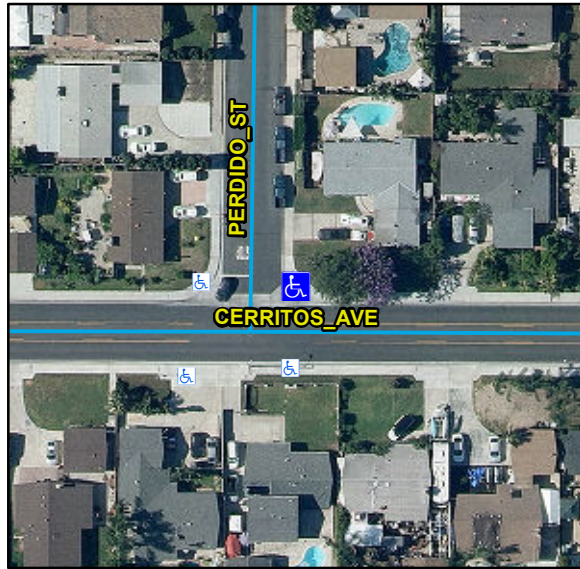
## Field Measurements/Component Compliance

| Compliance | Description | Data | Compliance | Description | Data |
|---|---|---|---|---|---|
| No | Landing Run Slope (%) | 2.1 | Yes | DWS Full Width | Yes |
| Yes | Gutter Ponding | No | No | Curb Slope | 9.4 |

**Remove & Replace Curb Ramp With Two New Directional Ramps or Equivalent.**

**R304.2.2, R304.2.2-Perp, R304.3.2-Para, STD 1115**
