# Access Compliance Report Public Rights-of-Way (Curb Ramps)

Main Street: CERRITOS\_AVE Cross Street: POONA\_DR Location: NW

ADA ID: RPAT220203133309 Ramp Type: Type 4 - Parallel Initial Pass/Fail: Fail Overall Compliance: No Severity Score: 34

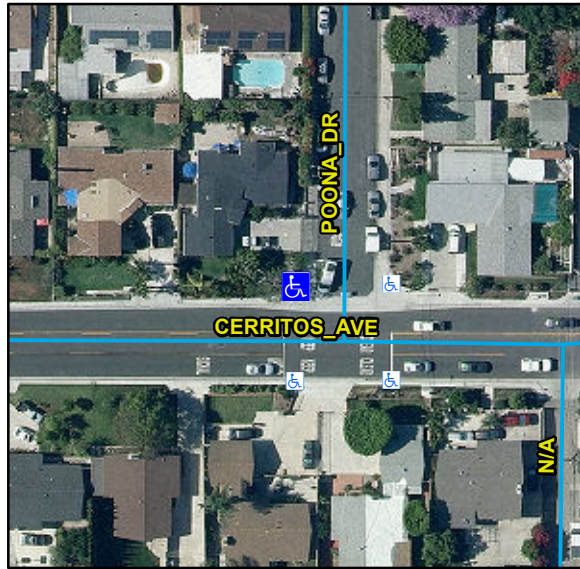
| Compliance | Description | Data | Compliance | Description | Data |
|---|---|---|---|---|---|
| No | Ramp Width LT (in) | 46 | Yes | Ramp Width RT (in) | 49 |
| Yes | Ramp Cross Slope LT (%) | 0.1 | No | Ramp Cross Slope RT (%) | 7.1 |

**Remove & Replace Curb Ramp With Two New Directional Ramps or Equivalent.**

**R304.5.1, R304.5.3, STD 1115**
