# Access Compliance Report Public Rights-of-Way (Curb Ramps)

Main Street: POONA\_DR Cross Street: CERRITOS\_AVE Location: NE

ADA ID: RPAT220203133545 Ramp Type: Type 4 - Parallel Initial Pass/Fail: Pass Overall Compliance: No Severity Score: 0

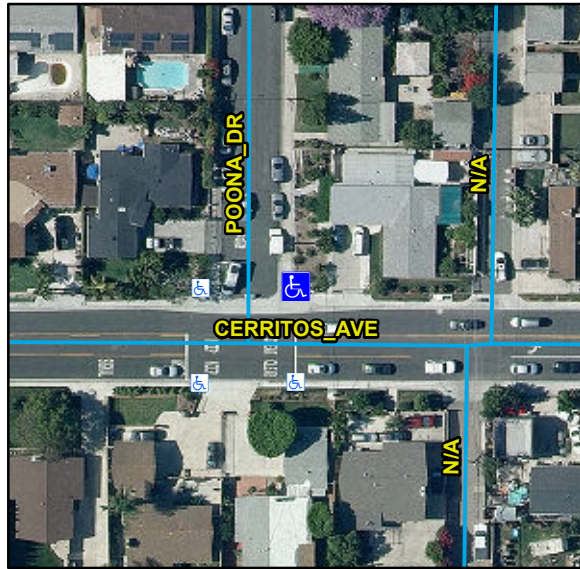
| Compliance | Description | Data | Compliance | Description | Data |
|---|---|---|---|---|---|
| No | Landing Run Slope (%) | 2.4 | Yes | DWS Full Width | Yes |

Possible Solutions:

Remove & Replace Landing.

R304.2.2-Perp, R304.3.2-Para, STD 1115

Total Cost: \$ 531
