# Access Compliance Report Public Rights-of-Way (Curb Ramps)

Main Street: CERRITOS\_AVE Cross Street: BROOKHURST\_ST Location: NW

ADA ID: RPAT220203134454 Ramp Type: Type 4 - Parallel Initial Pass/Fail: Pass Overall Compliance: No Severity Score: 0

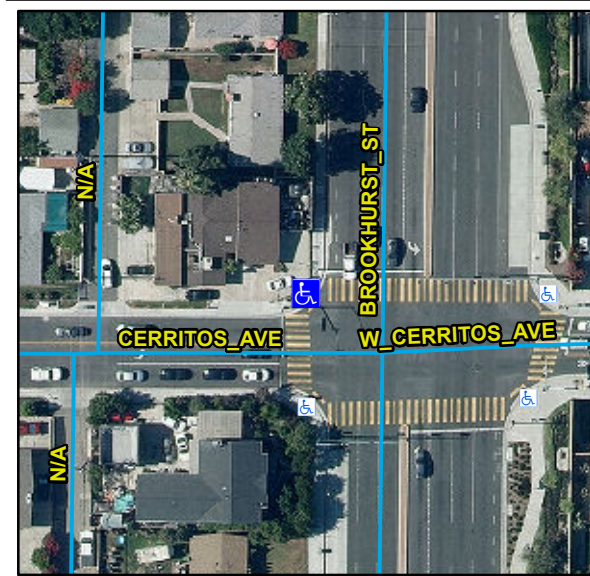
| Compliance | Description | Data | Compliance | Description | Data |
|---|---|---|---|---|---|
| Yes | Gutter Ponding | No | No | Curb Slope | 10 |

Possible Solutions:  
**Remove & Replace Curb Slope.**

OC Std/PROW:  
**R304.2.2, STD 1115**

Total Cost: \$ 252

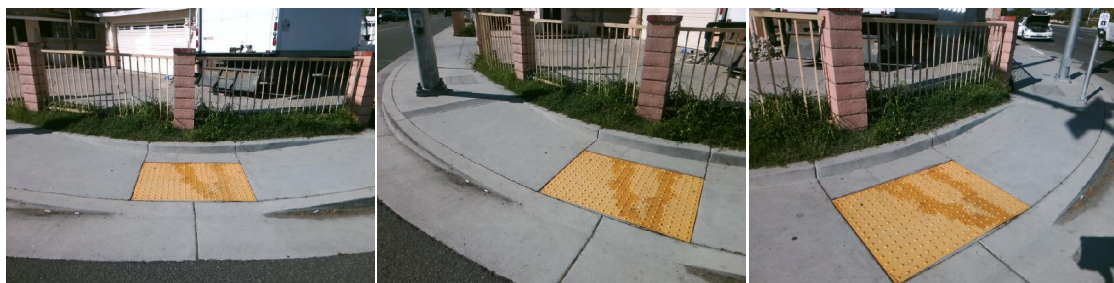
| Compliance | Description | Data | Compliance | Description | Data |
| N/A | Ramp Length LT (in) | 94 | N/A | Ramp Length RT (in) | 91 |
| Yes | Ramp Width LT (in) | 50 | Yes | Ramp Width RT (in) | 49 |
| Yes | Ramp Run Slope LT (%) | 5.3 | Yes | Ramp Run Slope RT (%) | 7 |
| Yes | Ramp Cross Slope LT (%) | 0.3 | Yes | Ramp Cross Slope RT (%) | 0.6 |
| N/A | Landing Present | Yes | Yes | DWS Provided | Yes |
