# Access Compliance Report Public Rights-of-Way (Curb Ramps)

Main Street: CERRITOS\_AVE Cross Street: CHAMBERLAIN\_AVE Location: SE

ADA ID: RPAT220203140153 Ramp Type: Type 4 - Parallel Initial Pass/Fail: Pass Overall Compliance: No Severity Score: 6

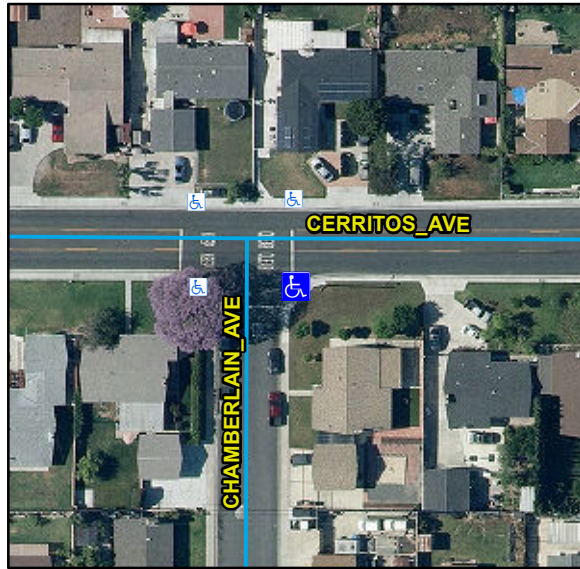
| Compliance | Description | Data | Compliance | Description | Data |
|---|---|---|---|---|---|
| No | Landing Run Slope (%) | 2.3 | Yes | DWS Full Width | Yes |
| No | Gutter Run Slope (%) | 5.8 | | Road Cross Slope (%) | N/A |

**Remove & Replace Landing. Remove & Replace Gutter.**
