# Access Compliance Report Public Rights-of-Way (Curb Ramps)

Main Street: CHAMBERLAIN\_AVE Cross Street: CERRITOS\_AVE Location: SW

ADA ID: RPAT220203140453 Ramp Type: Type 4 - Parallel Initial Pass/Fail: Fail Overall Compliance: No Severity Score: 2

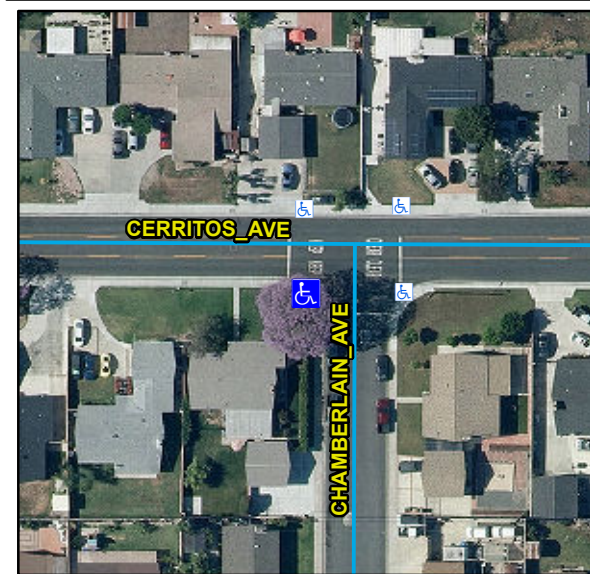
| Compliance | Description | Data | Compliance | Description | Data |
|---|---|---|---|---|---|
| Yes | Ramp Cross Slope LT (%) | 0.5 | No | Ramp Cross Slope RT (%) | 2.3 |

Possible Solutions:  
**Remove & Replace Curb Ramp With Two New Directional Ramps or Equivalent.**

OC Std/PROW:  
**R304.5.3, STD 1115**

Total Cost: \$ 4000
