# Access Compliance Report Public Rights-of-Way (Curb Ramps)

| Main Street: HEDLUND_DR | | Cross Street: HARLE_AVE | | Location: | NE |
| ADA ID: RPAT220203142926 | Ramp Type: Type 4 - Parallel | Initial Pass/Fail: Pass | Overall Compliance: No | Severity Score: | 5 |

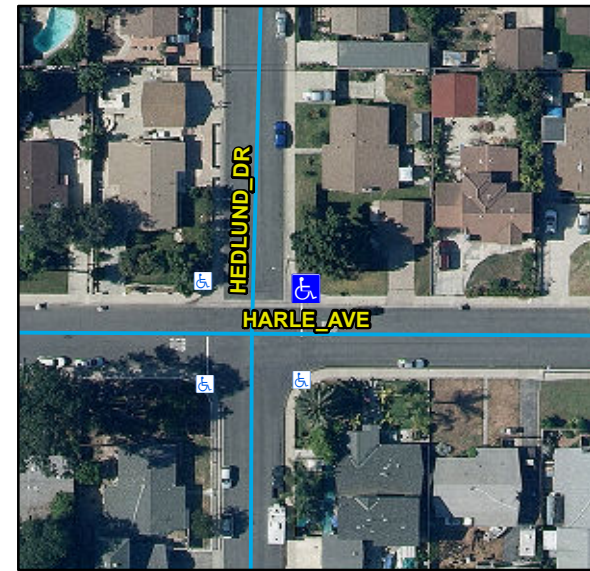
| Compliance | Description | Data | Compliance | Description | Data |
|---|---|---|---|---|---|
| No | Gutter Run Slope (%) | 5.1 | | Road Cross Slope (%) | 3.2 |

Possible Solutions:

Remove & Replace Gutter.

R304.5.4, STD 1115
