# Access Compliance Report Public Rights-of-Way (Curb Ramps)

Main Street: N/A Cross Street: CERRITOS\_AVE Location: NW

ADA ID: RPAT220203145000 Ramp Type: Type 1 - Perpendicular Initial Pass/Fail: Fail Overall Compliance: No Severity Score: 15

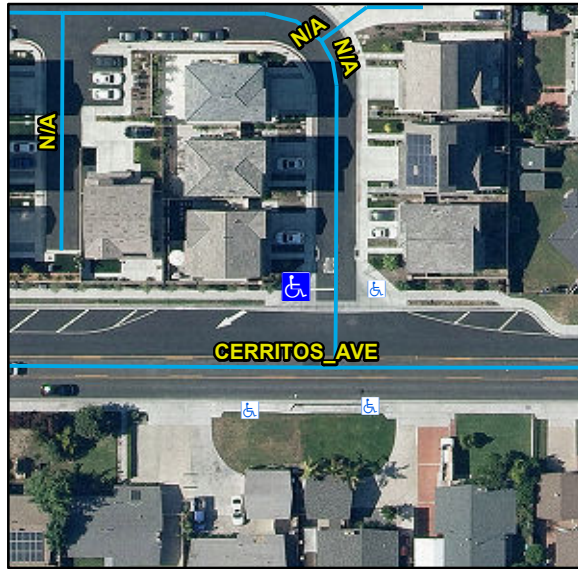
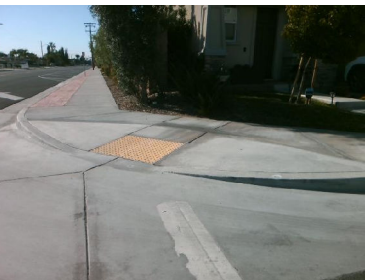
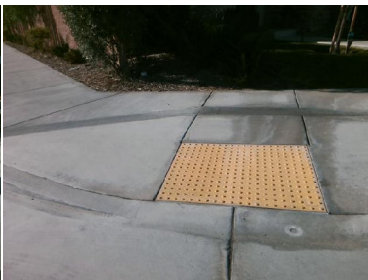
| Compliance | Description | Data | Compliance | Description | Data |
|---|---|---|---|---|---|
| No | Ramp Run Slope (%) | 8.6 | N/A | Flare Slope LT (%) | N/A |

Remove & Replace Entire Ramp.
