# Access Compliance Report Public Rights-of-Way (Curb Ramps)

| Main Street: CERRITOS_AVE | | Cross Street: N/A | | Location: | NE |
| ADA ID: RPAT220203145459 | Ramp Type:Type 1 - Perpendicular | Initial Pass/Fail: Pass | Overall Compliance: No | Severity Score: | 4 |

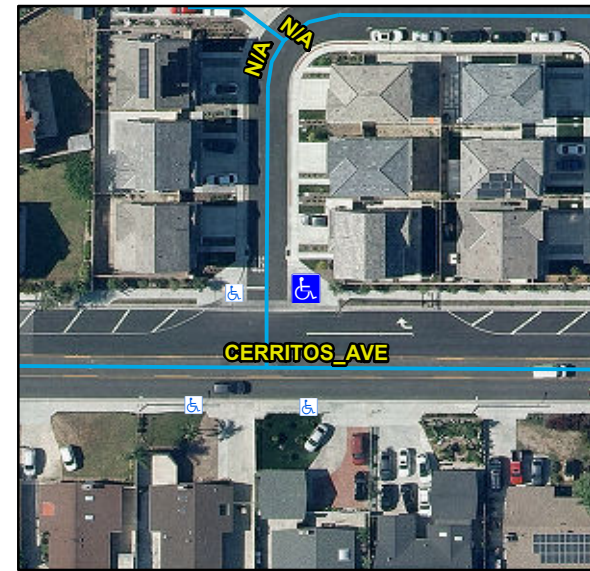
R304.2.1, STD 1115

| Compliance | Description | Data | Compliance | Description | Data |
|---|---|---|---|---|---|
| N/A | Landing Length (in) | 37 | | | Sloped |

Remove & Replace Landing.

Total Cost: \$ 531
