# Access Compliance Report Public Rights-of-Way (Curb Ramps)

Main Street: POONA\_DR Cross Street: HARRIET\_LN Location: SW

ADA ID: RPAT220203154345 Ramp Type: Type 4 - Parallel Initial Pass/Fail: Fail Overall Compliance: No Severity Score: 15

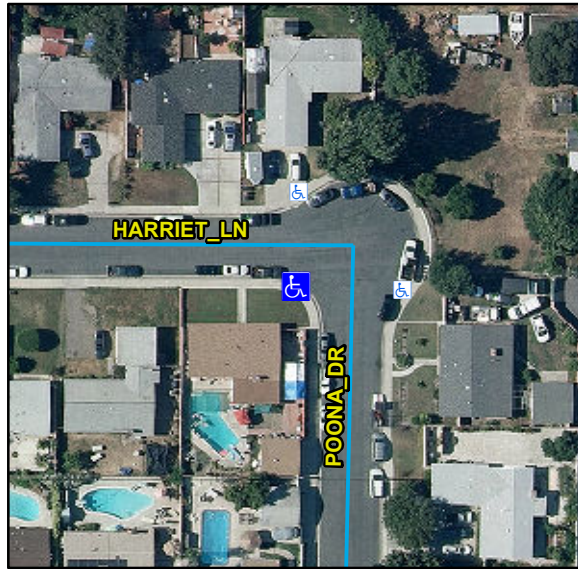
| Compliance | Description | Data | Compliance | Description | Data |
|---|---|---|---|---|---|
| No | Ramp Run Slope LT (%) | 8.7 | Yes | Ramp Run Slope RT (%) | 7.2 |

**Remove & Replace Curb Ramp With Two New Directional Ramps or Equivalent.**

**R304.3.2, STD 1115**

Total Cost: \$ 4000
