# Access Compliance Report Public Rights-of-Way (Curb Ramps)

| Main Street: LULLABY_LN | | Cross Street: POONA_DR | | Location: | NW |
| ADA ID: RPAT220203155032 | Ramp Type: Type 4 - Parallel | Initial Pass/Fail: Pass | Overall Compliance: No | Severity Score: | 5 |

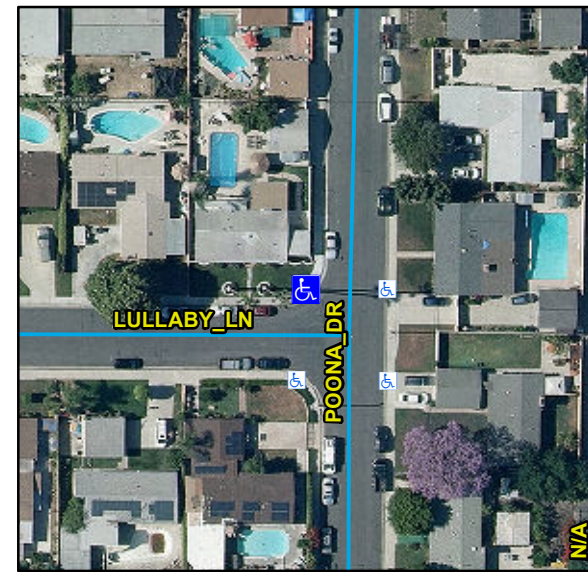
| Compliance | Description | Data | Compliance | Description | Data |
|---|---|---|---|---|---|
| Yes | Gutter Ponding | No | No | Curb Slope | 8.4 |
| No | Gutter Run Slope (%) | 6.3 | | Road Cross Slope (%) | N/A |

Possible Solutions:

**Remove & Replace Curb Slope. Remove & Replace Gutter.**

**R304.2.2, R304.5.4, STD 1115**

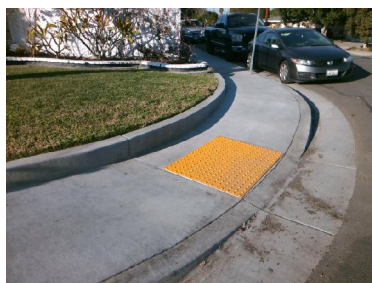
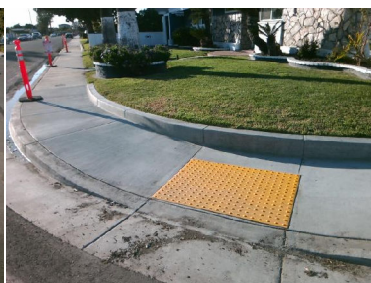
| Compliance | Description | Data | Compliance | Description | Data |
|---|---|---|---|---|---|
| N/A | Ramp Length LT (in) | 84 | N/A | Ramp Length RT (in) | 85 |
| Yes | Ramp Width LT (in) | 54 | Yes | Ramp Width RT (in) | 53 |
| Yes | Ramp Run Slope LT (%) | 5.4 | Yes | Ramp Run Slope RT (%) | 7.7 |
| Yes | Ramp Cross Slope LT (%) | 1 | Yes | Ramp Cross Slope RT (%) | 0.7 |
