# Access Compliance Report Public Rights-of-Way (Curb Ramps)

Main Street: N/A Cross Street: SENDERO\_WAY Location: W

ADA ID: RPAT220208102234 Ramp Type: Type 7 - Directional 2 Initial Pass/Fail: Fail Overall Compliance: No Severity Score: 15

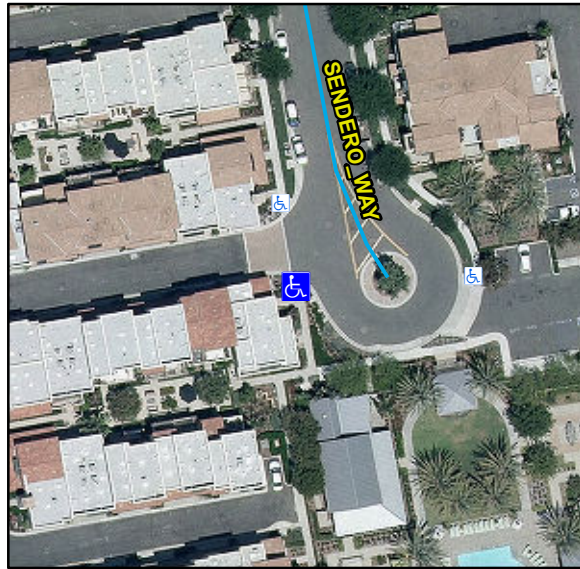
| Compliance | Description | Data | Compliance | Description | Data |
|---|---|---|---|---|---|
| No | Ramp Run Slope (%) | 8.74 | N/A | Flare Slope LT (%) | N/A |

Remove & Replace Entire Ramp.

R304.2.2, STD 1115
