# Access Compliance Report Public Rights-of-Way (Curb Ramps)

Main Street: N/A Cross Street: SENDERO WAY Location: W

ADA ID: RPAT220208102502 Ramp Type: Type 6 - Directional 1 Initial Pass/Fail: Pass Overall Compliance: No Severity Score: 6

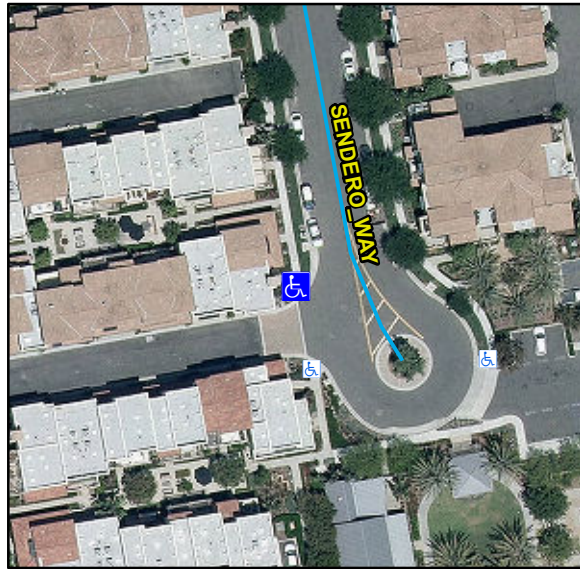
| Compliance | Description | Data | Compliance | Description | Data |
|---|---|---|---|---|---|
| No | Gutter Run Slope (%) | 6 | | Road Cross Slope (%) | N/A |

Remove & Replace Gutter.

R304.5.4, STD 1115

Total Cost: \$ 252
