# Access Compliance Report Public Rights-of-Way (Curb Ramps)

Main Street: **OSO\_PKWY** Cross Street: **SOLANO** Location: **N**

ADA ID: **RPAT220208111215** Ramp Type: **Type 1 - Perpendicular Diagonal** Initial Pass/Fail: **Fail** Overall Compliance: **No** Severity Score: **2**

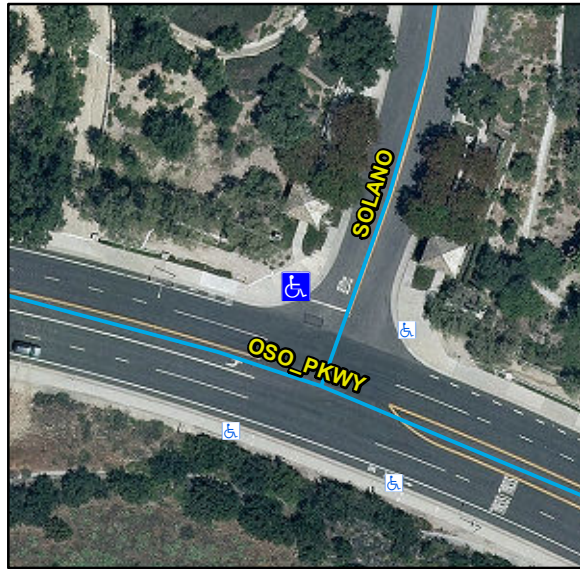
| Compliance | Description | Data | Compliance | Description | Data |
|---|---|---|---|---|---|
| <b>N/A</b> | Ramp Length (in) | <b>129</b> | <b>N/A</b> | Flare Type LT | |
| <b>Yes</b> | Ramp Width (in) | <b>48</b> | | | <b>N/A</b> |
| <b>Yes</b> | Ramp Run Slope (%) | <b>5.6</b> | <b>N/A</b> | Flare Slope LT (%) | <b>N/A</b> |
| <b>No</b> | Ramp Cross Slope (%) | <b>3.4</b> | <b>N/A</b> | Flare Traversable LT | <b>N/A</b> |

**Remove & Replace Curb Ramp With Two New Directional Ramps or Equivalent.**

**R304.2.2, R304.5.3, STD 1115**
