# Access Compliance Report Public Rights-of-Way (Curb Ramps)

Main Street: SOLANO Cross Street: OSO\_PKWY Location: E

ADA ID: RPAT220208111530 Ramp Type: Type 1 - Perpendicular Diagonal Initial Pass/Fail: Fail Overall Compliance: No Severity Score: 30

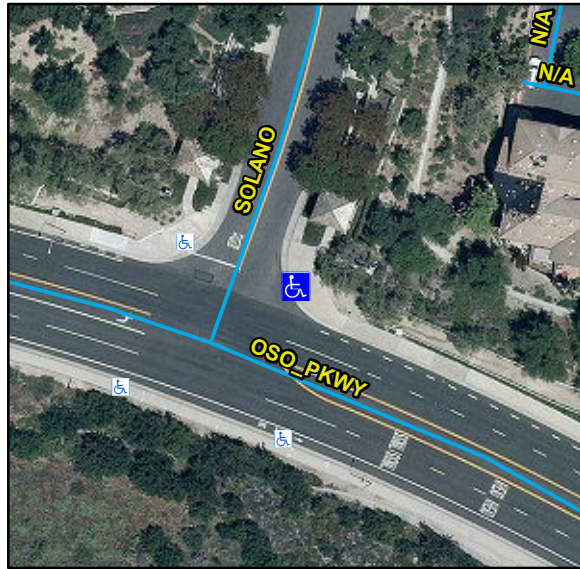
| Compliance | Description | Data | Compliance | Description | Data |
|---|---|---|---|---|---|
| No | Ramp Cross Slope (%) | 9.5 | N/A | Flare Traversable LT | N/A |
| No | Gutter Lip Height (in) | 0.25 | | Road Run Slope (%) | 5.6 |

Remove & Replace Curb Ramp With Two New Directional Ramps or Equivalent.

R304.2.2, R204.3, R304.5.3, R302.7.2, STD 1115
