# Access Compliance Report Public Rights-of-Way (Curb Ramps)

| Main Street: <b>OSO_PKWY</b> | | Cross Street: <b>N/A</b> | | Location: <b>NE</b> |
| ADA ID: <b>RPAT220208112553</b> | Ramp Type: <b>Type 4 - Parallel</b> | Initial Pass/Fail: <b>Fail</b> | Overall Compliance: <b>No</b> | Severity Score: <b>15</b> |

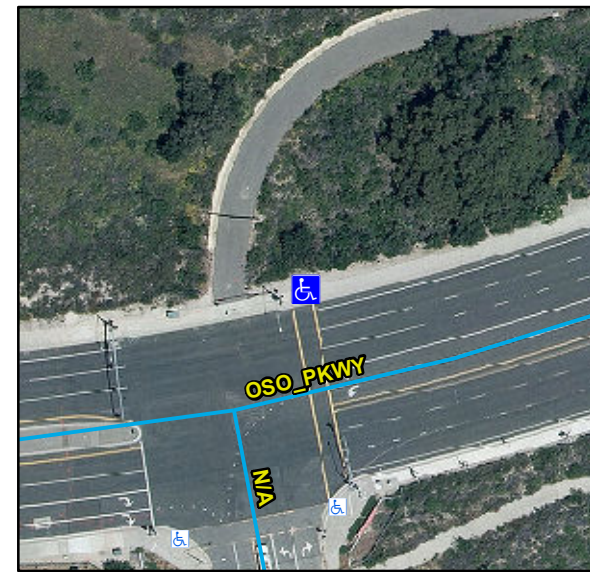
| Compliance | Description | Data | Compliance | Description | Data |
|---|---|---|---|---|---|
| <b>No</b> | Ramp Run Slope LT (%) | <b>9.46</b> | <b>Yes</b> | Ramp Run Slope RT (%) | <b>5.3</b> |

**Remove & Replace Entire Ramp.**

**R304.3.2, STD 1115**

Total Cost: \$ **2000**
