# Access Compliance Report Public Rights-of-Way (Curb Ramps)

Main Street: **OSO\_PKWY** Cross Street: **N/A** Location: **S**

ADA ID: **RPAT220208113033** Ramp Type: **Type 1 - Perpendicular Diagonal** Initial Pass/Fail: **Pass** Overall Compliance: **No** Severity Score: **10**

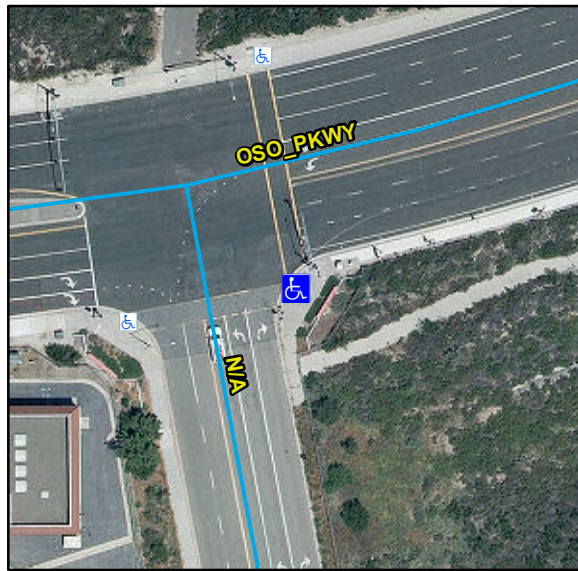
| Compliance | Description | Data | Compliance | Description | Data |
|---|---|---|---|---|---|
| No | Clear Space | Yes | Yes | DWS Offset Left (in) | 1 |
| No | Clear Space To Crosswalk (in) | 24 | Yes | DWS Offset Right (in) | N/A |
| No | Ramp Inside Crosswalk 1 | No | Yes | Ramp Inside Crosswalk 2 | No |
| Yes | Gutter Ponding | No | No | Curb Slope | 11.5 |
| No | Gutter Run Slope (%) | 9.8 | | Road Cross Slope (%) | 2.6 |

**Remove & Replace Curb Ramp With Two New Directional Ramps or Equivalent. Restripe Crosswalk(s) To Provide Clear space. Remove & Replace Gutter.**
