# Access Compliance Report Public Rights-of-Way (Curb Ramps)

Main Street: N/A Cross Street: OSO\_PKWY Location: SW

ADA ID: RPAT220208114227 Ramp Type: Type 1 - Perpendicular Diagonal Initial Pass/Fail: Fail Overall Compliance: No Severity Score: 30

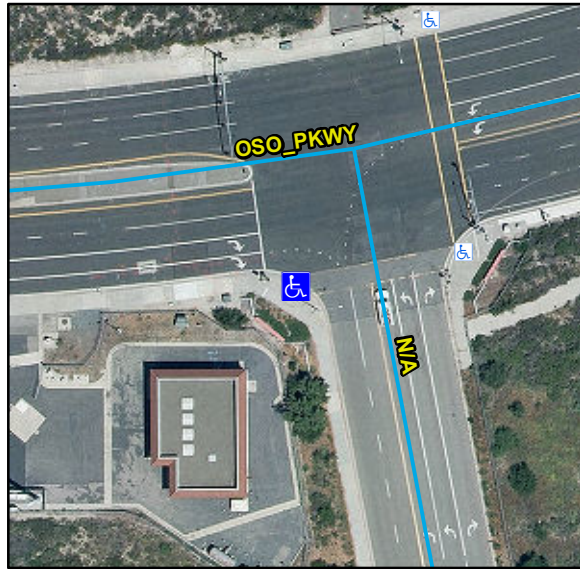
| Compliance | Description | Data | Compliance | Description | Data |
|---|---|---|---|---|---|
| No | Ramp Cross Slope (%) | 9.14 | N/A | Flare Traversable LT | N/A |

Remove & Replace Curb Ramp With Two New Directional Ramps or Equivalent.

R304.2.2, R304.5.3, STD 1115
