# Access Compliance Report Public Rights-of-Way (Curb Ramps)

Main Street: GREENVALE Cross Street: WOODSONG Location: N

ADA ID: RPAT220208115322 Ramp Type: Type 1 - Perpendicular Diagonal Initial Pass/Fail: Fail Overall Compliance: No Severity Score: 4

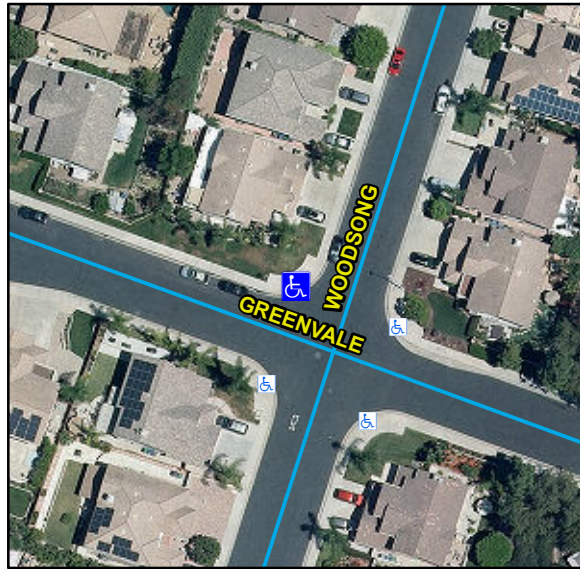
| Compliance | Description | Data | Compliance | Description | Data |
|---|---|---|---|---|---|
| No | Ramp Width (in) | 46 | | | N/A |

**Remove & Replace Curb Ramp With Two New Directional Ramps or Equivalent.**

**R204.3, R304.5.1, STD 1115**
