# Access Compliance Report Public Rights-of-Way (Curb Ramps)

Main Street: GREENVALE Cross Street: MEADOWOOD Location: N

ADA ID: RPAT220208115949 Ramp Type: Type 1 - Perpendicular Diagonal Initial Pass/Fail: Fail Overall Compliance: No Severity Score: 45

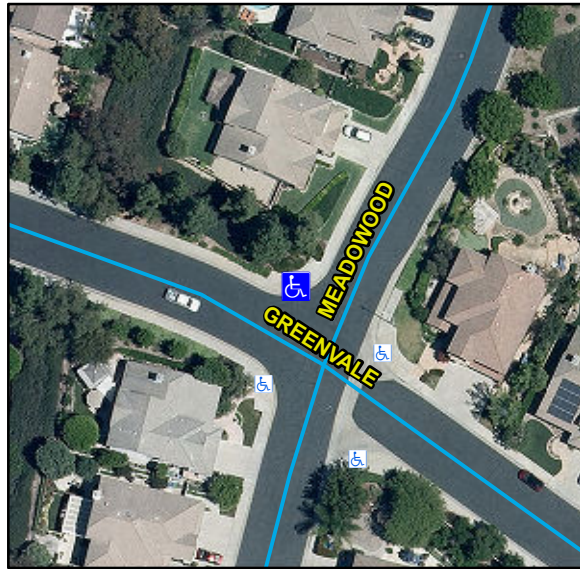
| Compliance | Description | Data | Compliance | Description | Data |
|---|---|---|---|---|---|
| No | Ramp Run Slope (%) | 9.8 | N/A | Flare Slope LT (%) | N/A |
| No | Ramp Cross Slope (%) | 9.98 | N/A | Flare Traversable LT | N/A |
| No | Gutter Lip Height (in) | 0.5 | | Road Run Slope (%) | 8.38 |

Remove & Replace Curb Ramp With Two New Directional Ramps or Equivalent.
