# Access Compliance Report Public Rights-of-Way (Curb Ramps)

Main Street: MEADOWOOD Cross Street: GREENVALE Location: E

ADA ID: RPAT220208120217 Ramp Type: Type 1 - Perpendicular Diagonal Initial Pass/Fail: Fail Overall Compliance: No Severity Score: 35

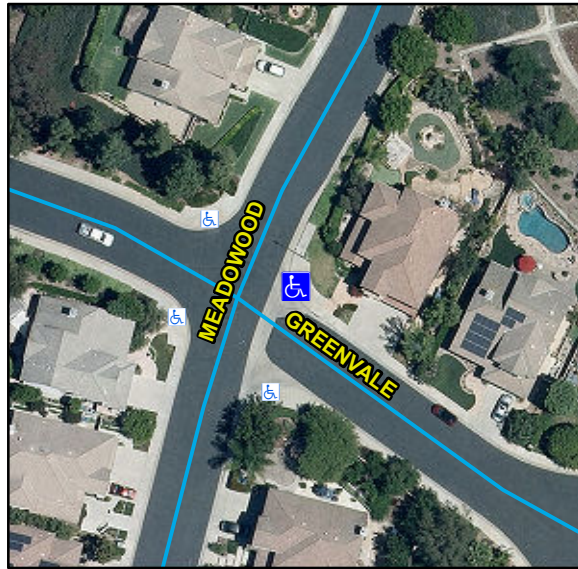
| Compliance | Description | Data | Compliance | Description | Data |
|---|---|---|---|---|---|
| No | Ramp Width (in) | 46 | | | N/A |
| No | Ramp Run Slope (%) | 13.7 | N/A | Flare Slope LT (%) | N/A |
| No | Ramp Cross Slope (%) | 2.3 | N/A | Flare Traversable LT | N/A |

Remove & Replace Curb Ramp With Two New Directional Ramps or Equivalent.

R304.2.2, R204.3, R304.5.1, R304.5.3, STD 1115
