# Access Compliance Report Public Rights-of-Way (Curb Ramps)

Main Street: ANTONIO\_PKWY Cross Street: N/A Location: W

ADA ID: RPAT220208121808 Ramp Type: Type 1 - Perpendicular Diagonal Initial Pass/Fail: Pass Overall Compliance: No Severity Score: 42

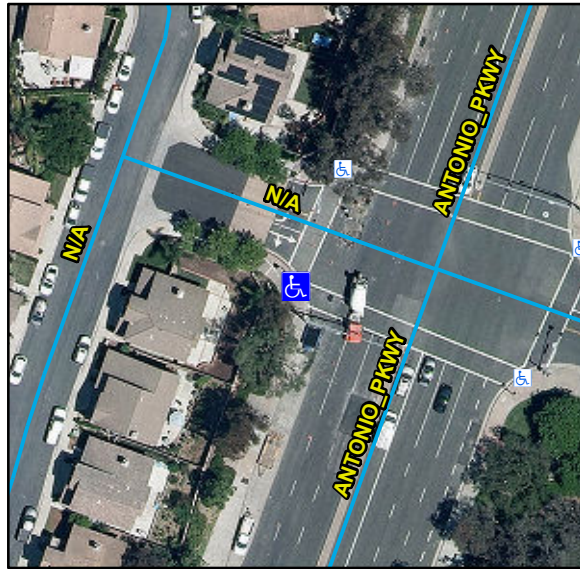
| Compliance | Description | Data | Compliance | Description | Data |
|---|---|---|---|---|---|
| No | Landing Run Slope (%) | 2.77 | N/A | Flare Traversable RT | No |
| No | Gutter Lip Height (in) | 1 | | Road Run Slope (%) | 0.6 |
| No | Gutter Run Slope (%) | 9.6 | | Road Cross Slope (%) | 4.5 |
| No | Overall Surface Condition: | Poor | No | Perp Joint Present | No |

Remove & Replace Curb Ramp With Two New Directional Ramps or Equivalent. Remove & Replace Gutter.
