# Access Compliance Report Public Rights-of-Way (Curb Ramps)

Main Street: N/A Cross Street: ANTONIO\_PKWY Location: N

ADA ID: RPAT220208122628 Ramp Type: Type 1 - Perpendicular Diagonal Initial Pass/Fail: Pass Overall Compliance: No Severity Score: 42

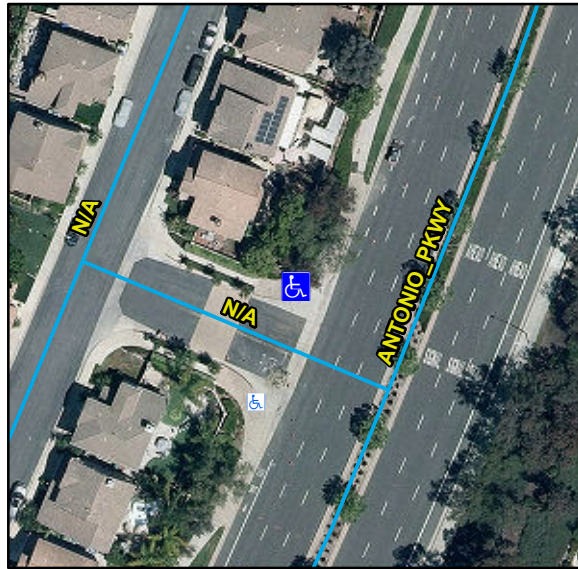
| Compliance | Description | Data | Compliance | Description | Data |
|---|---|---|---|---|---|
| No | Landing Run Slope (%) | 4.64 | N/A | Flare Traversable RT | Yes |
| Yes | Landing Cross Slope (%) | 0.9 | No | DWS Provided | No |
| No | Gutter Lip Height (in) | 1 | | Road Run Slope (%) | 2 |
| No | Overall Surface Condition: | Poor | Yes | Perp Joint Present | Yes |

Remove & Replace Curb Ramp With Two New Directional Ramps or Equivalent. Grind Gutter Lip.
