# Access Compliance Report Public Rights-of-Way (Curb Ramps)

Main Street: ANTONIO\_PKWY Cross Street: N/A Location: W

ADA ID: RPAT220208123025 Ramp Type: Type 1 - Perpendicular Diagonal Initial Pass/Fail: Pass Overall Compliance: No Severity Score: 18

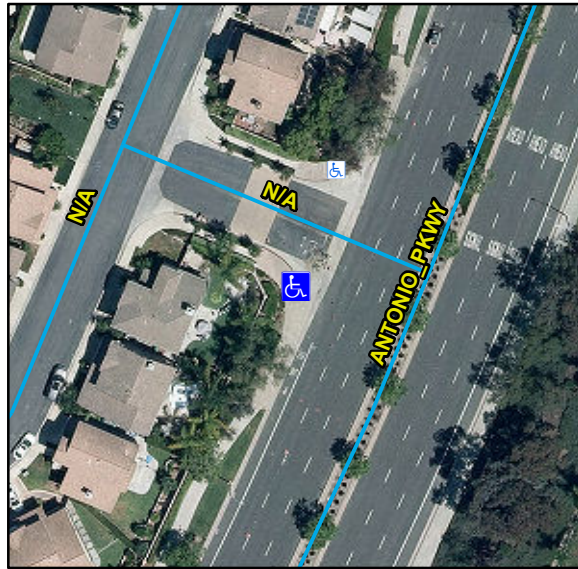
| Compliance | Description | Data | Compliance | Description | Data |
|---|---|---|---|---|---|
| No | Landing Run Slope (%) | 2.3 | N/A | Flare Traversable RT | Yes |
| Yes | Landing Cross Slope (%) | 1.73 | No | DWS Provided | No |
| No | Gutter Lip Height (in) | 0.5 | | Road Run Slope (%) | 2.7 |
| No | Gutter Cross Slope (%) | 2.5 | | | |

Remove & Replace Curb Ramp With Two New Directional Ramps or Equivalent. Remove & Replace Gutter.
