# Access Compliance Report Public Rights-of-Way (Curb Ramps)

Main Street: N/A Cross Street: ANTONIO\_PKWY Location: N

ADA ID: RPAT220208123617 Ramp Type: Type 1 - Perpendicular Diagonal Initial Pass/Fail: Fail Overall Compliance: No Severity Score: 2

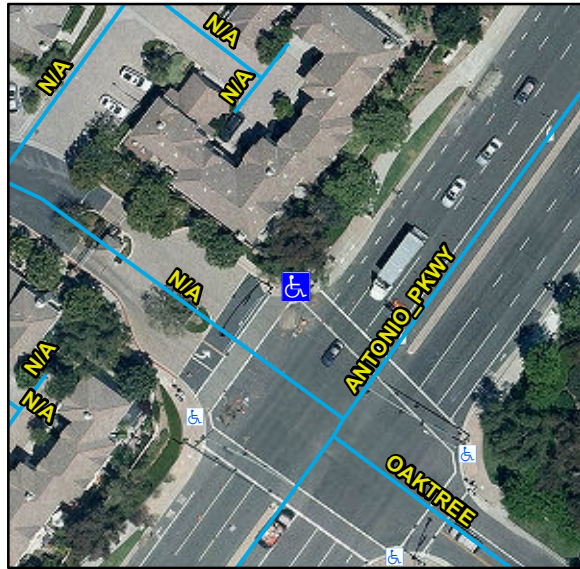
| Compliance | Description | Data | Compliance | Description | Data |
|---|---|---|---|---|---|
| No | Ramp Cross Slope (%) | 2.8 | N/A | Flare Traversable LT | N/A |
| No | Gutter Lip Height (in) | 0.28 | | Road Run Slope (%) | 1.47 |

Remove & Replace Curb Ramp With Two New Directional Ramps or Equivalent. Grind Gutter Lip.

R204.3, R304.5.3, R302.7.2, STD 1115
