# Access Compliance Report Public Rights-of-Way (Curb Ramps)

Main Street: ANTONIO\_PKWY Cross Street: N/A Location: NW

ADA ID: RPAT220208124059 Ramp Type: Type 1 - Perpendicular Diagonal Initial Pass/Fail: Fail Overall Compliance: No Severity Score: 0

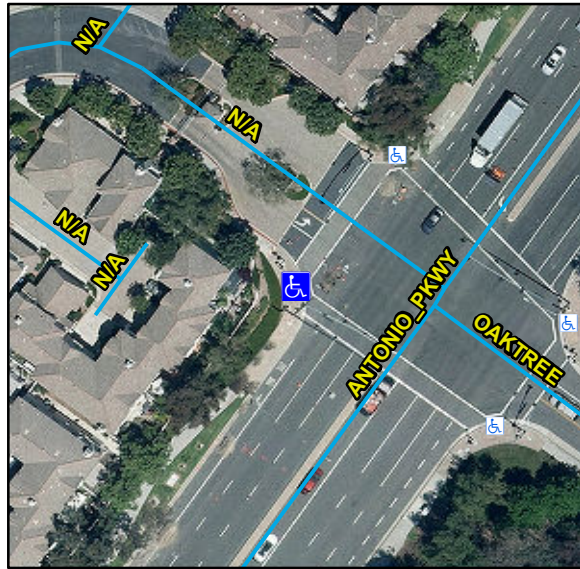
| Compliance | Description | Data | Compliance | Description | Data |
|---|---|---|---|---|---|
| No | Gutter Lip Height (in) | 0.25 | | Road Run Slope (%) | 4.99 |

Remove & Replace Curb Ramp With Two New Directional Ramps or Equivalent. Grind Gutter Lip.
