# Access Compliance Report Public Rights-of-Way (Curb Ramps)

Main Street: N/A Cross Street: ANTONIO\_PKWY Location: N

ADA ID: RPAT220208124748 Ramp Type: Type 1 - Perpendicular Diagonal Initial Pass/Fail: Fail Overall Compliance: No Severity Score: 15

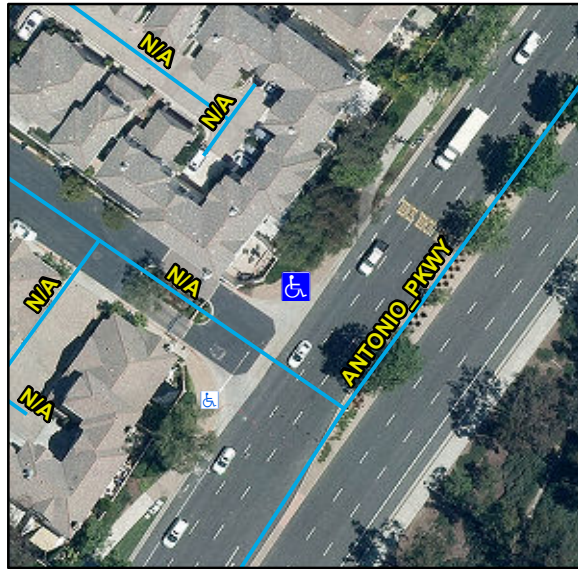
| Compliance | Description | Data | Compliance | Description | Data |
|---|---|---|---|---|---|
| No | Ramp Run Slope (%) | 9.37 | N/A | Flare Slope LT (%) | N/A |
| No | Gutter Lip Height (in) | 0.25 | | Road Run Slope (%) | 1.56 |

Remove & Replace Curb Ramp With Two New Directional Ramps or Equivalent. Grind Gutter Lip.
