# Access Compliance Report Public Rights-of-Way (Curb Ramps)

Main Street: ANTONIO\_PKWY Cross Street: N/A Location: W

ADA ID: RPAT220208125020 Ramp Type: Type 1 - Perpendicular Diagonal Initial Pass/Fail: Fail Overall Compliance: No Severity Score: 2

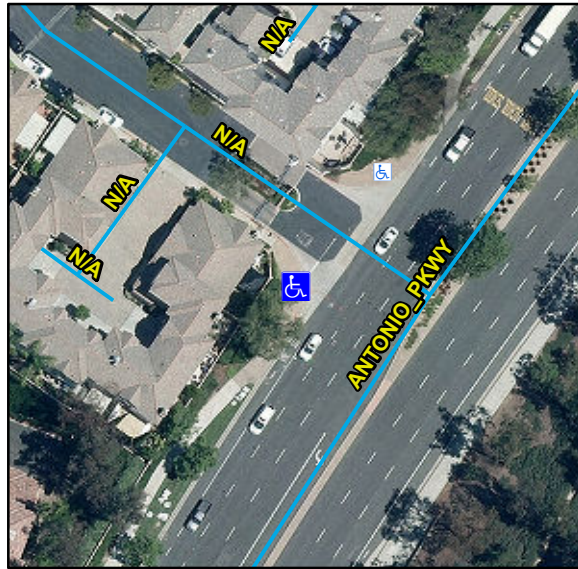
| Compliance | Description | Data | Compliance | Description | Data |
|---|---|---|---|---|---|
| No | Ramp Cross Slope (%) | 2.3 | N/A | Flare Traversable LT | N/A |
| No | Gutter Lip Height (in) | 0.25 | | Road Run Slope (%) | 3.21 |

Remove & Replace Curb Ramp With Two New Directional Ramps or Equivalent. Grind Gutter Lip.
