# Access Compliance Report Public Rights-of-Way (Curb Ramps)

Main Street: N/A Cross Street: ANTONIO\_PKWY Location: W

ADA ID: RPAT220208125825 Ramp Type: Type 1 - Perpendicular Diagonal Initial Pass/Fail: Fail Overall Compliance: No Severity Score: 2

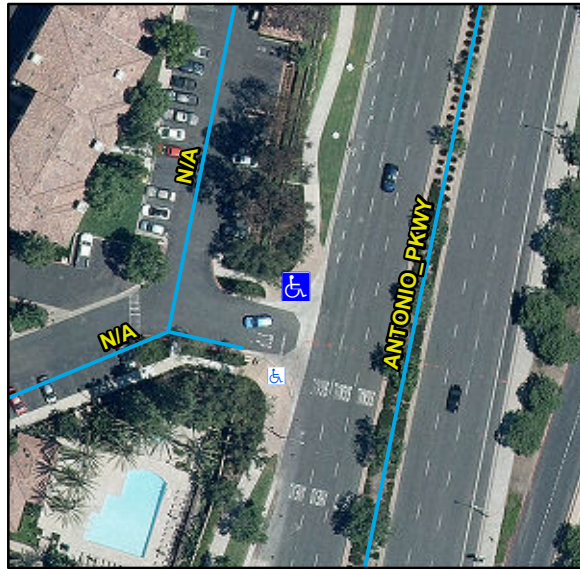
| Compliance | Description | Data | Compliance | Description | Data |
|---|---|---|---|---|---|
| No | Ramp Cross Slope (%) | 4.1 | N/A | Flare Traversable LT | N/A |
| N/A | Gutter Ponding | N/A | No | Curb Slope | 8.1 |

Remove & Replace Curb Ramp With Two New Directional Ramps or Equivalent.
