# Access Compliance Report Public Rights-of-Way (Curb Ramps)

**Main Street:** ANTONIO\_PKWY      **Cross Street:** N/A      **Location:** W

**ADA ID:** RPAT220208130010      **Ramp Type:**Type 1 - Perpendicular Diagonal Initial Pass/Fail: Fail      **Overall Compliance:** No      **Severity Score:** 16

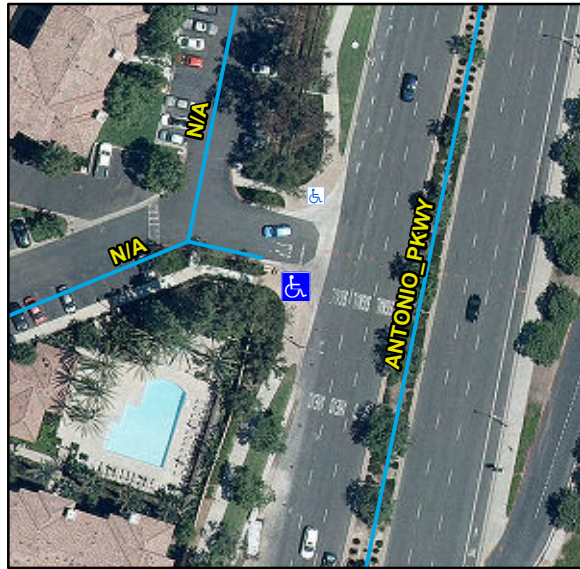
Compliance	Description	Data	Compliance	Description	Data
N/A	Ramp Length (in)	116	N/A	Flare Type LT	
Yes	Ramp Width (in)	52			N/A
Yes	Ramp Run Slope (%)	8.02	N/A	Flare Slope LT (%)	N/A
No	Ramp Cross Slope (%)	2.2	N/A	Flare Traversable LT	N/A
N/A	Landing Present	N/A	N/A	Flare Type RT	
N/A	Landing Length (in)	N/A			N/A
N/A	Landing Width (in)	N/A	N/A	Flare Slope RT (%)	N/A
N/A	Landing Run Slope (%)	N/A	N/A	Flare Traversable RT	N/A
N/A	Landing Cross Slope (%)	N/A	N/A	DWS Provided	N/A
N/A	Landing Movement Obstructed?	N/A	N/A	DWS Contrast	N/A
	Landing Movement Type	N/A	N/A	DWS Length (in)	N/A
N/A	Landing Shared	N/A	N/A	DWS Full Width	N/A
N/A	Clear Space	Yes	N/A	DWS Offset Left (in)	N/A
N/A	Clear Space To Crosswalk (in)	N/A	N/A	DWS Offset Right (in)	N/A
N/A	Marked Crosswalk 1	No	N/A	Marked Crosswalk 2	No
	Crossing 1 Direction	SE		Crossing 2 Direction	NE
	Marked Crosswalk 1 Width (in)	N/A		Marked Crosswalk 2 Width (in)	N/A

N/A	Ramp Inside Crosswalk 1	N/A	Yes	Ramp Inside Crosswalk 2	N/A
	Crossing 1 Slope (%)	1.6		Crossing 2 Slope (%)	4.2
	Crossing 1 Cross Slope (%)	2.08		Crossing 2 Cross Slope (%)	2.42
N/A	Gutter Ponding	N/A	N/A	Curb Slope	1.4
Yes	Gutter Lip Height (in)	0		Road Run Slope (%)	2.42
N/A	Gutter Run Slope (%)	N/A		Road Cross Slope (%)	3.4
N/A	Gutter Cross Slope (%)	N/A			
No	Overall Surface Condition:	Poor	No	Perp Joint Present	No
	Cross Gutter Present?	Yes		Spandrel Present?	Yes
	Replace Cross Gutter?	No		Replace Spandrel?	No

**Remove & Replace Curb Ramp With Two New Directional Ramps or Equivalent.**

**R204.3, R304.5.3, R302.7, STD 1115**
