# Access Compliance Report Public Rights-of-Way (Curb Ramps)

Main Street: N/A Cross Street: OSO\_PKWY Location: W

ADA ID: RPAT220208131404 Ramp Type: Type 1 - Perpendicular Diagonal Initial Pass/Fail: Fail Overall Compliance: No Severity Score: 15

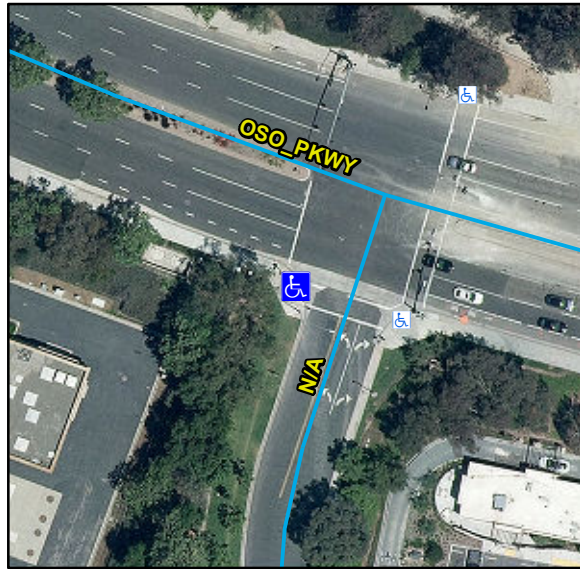
R304.2.2, R204.3, R304.5.3, R302.7.2, STD 1115

| Compliance | Description | Data | Compliance | Description | Data |
|---|---|---|---|---|---|
| No | Ramp Cross Slope (%) | 6.8 | N/A | Flare Traversable LT | N/A |
| No | Gutter Lip Height (in) | 0.25 | | Road Run Slope (%) | 5.42 |

Remove & Replace Curb Ramp With Two New Directional Ramps or Equivalent.

Total Cost: \$ 6160
