# Access Compliance Report Public Rights-of-Way (Curb Ramps)

| Main Street: <b>OSO_PKWY</b> | | Cross Street: <b>N/A</b> | | Location: <b>NE</b> |
| ADA ID: <b>RPAT220208131724</b> | Ramp Type: <b>Type 4 - Parallel</b> | Initial Pass/Fail: <b>Fail</b> | Overall Compliance: <b>No</b> | Severity Score: <b>16</b> |

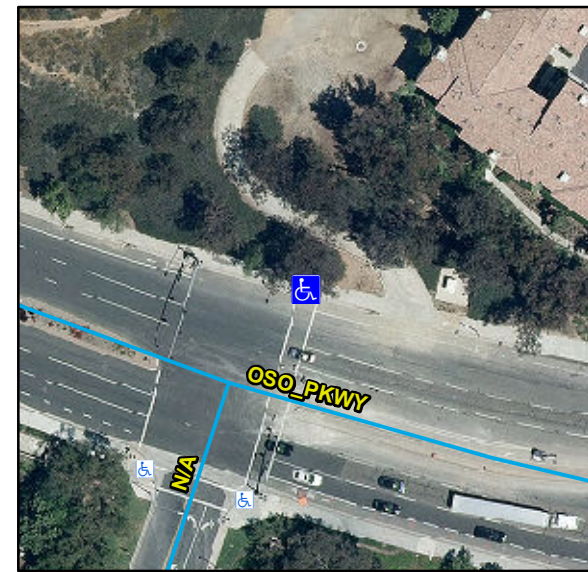
| Compliance | Description | Data | Compliance | Description | Data |
|---|---|---|---|---|---|
| <b>Yes</b> | Ramp Run Slope LT (%) | <b>4.8</b> | <b>No</b> | Ramp Run Slope RT (%) | <b>11.7</b> |
| <b>No</b> | Ramp Cross Slope LT (%) | <b>3.66</b> | <b>Yes</b> | Ramp Cross Slope RT (%) | <b>1.3</b> |

**Remove & Replace Entire Ramp.**

**R304.5.3, R304.3.2, STD 1115**
