# Access Compliance Report Public Rights-of-Way (Curb Ramps)

Main Street: N/A Cross Street: OSO\_PKWY Location: S

ADA ID: RPAT220208133230 Ramp Type: Type 7 - Directional 2 Initial Pass/Fail: Fail Overall Compliance: No Severity Score: 15

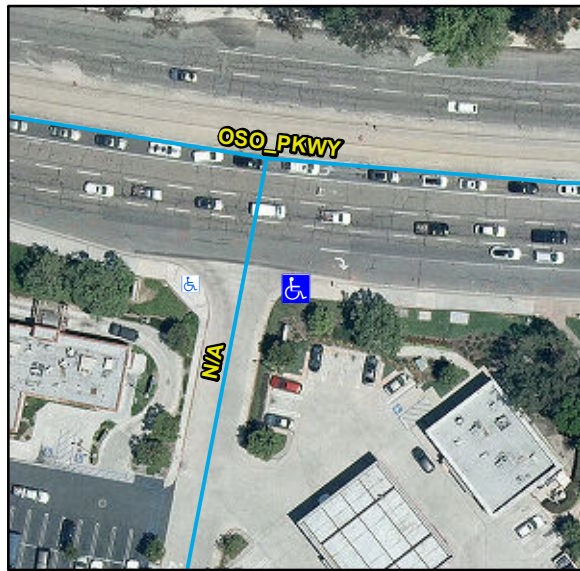
| Compliance | Description | Data | Compliance | Description | Data |
|---|---|---|---|---|---|
| N/A | Ramp Length (in) | 205 | N/A | Flare Type LT | |
| Yes | Ramp Width (in) | 60 | | | N/A |
| Yes | Ramp Run Slope (%) | 8.5 | N/A | Flare Slope LT (%) | N/A |
| Yes | Ramp Cross Slope (%) | 0.4 | N/A | Flare Traversable LT | N/A |
| Yes | Overall Surface Condition | Acceptable | No | Perp Joint Present | No |

Possible Solutions:

Remove & Replace Entire Ramp.

R204.3, STD 1115
