# Access Compliance Report Public Rights-of-Way (Curb Ramps)

Main Street: N/A Cross Street: OSO\_PKWY Location: SW

ADA ID: RPAT220208133441 Ramp Type: Type 1 - Perpendicular Diagonal Initial Pass/Fail: Fail Overall Compliance: No Severity Score: 45

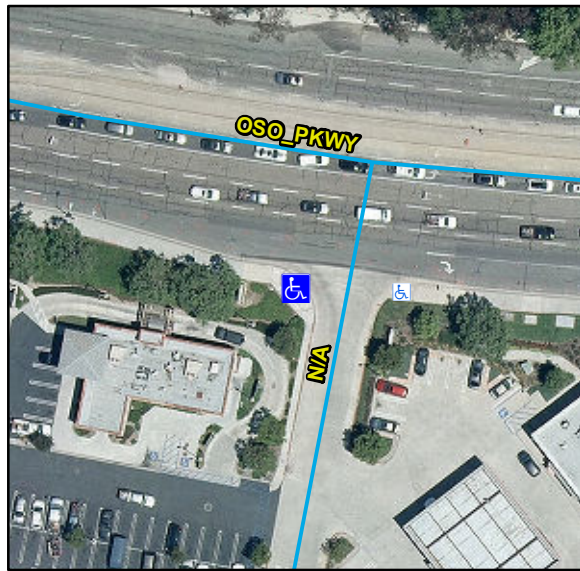
| Compliance | Description | Data | Compliance | Description | Data |
|---|---|---|---|---|---|
| No | Ramp Run Slope (%) | 8.4 | N/A | Flare Slope LT (%) | N/A |
| No | Ramp Cross Slope (%) | 8.6 | N/A | Flare Traversable LT | N/A |

Remove & Replace Curb Ramp With Two New Directional Ramps or Equivalent.

R304.2.2, R204.3, R304.5.3, STD 1115
