# Access Compliance Report Public Rights-of-Way (Curb Ramps)

Main Street: N/A Cross Street: ANTONIO\_PKWY Location: NW

ADA ID: RPAT220208133901 Ramp Type: Type 4 - Parallel Initial Pass/Fail: Pass Overall Compliance: No Severity Score: 0

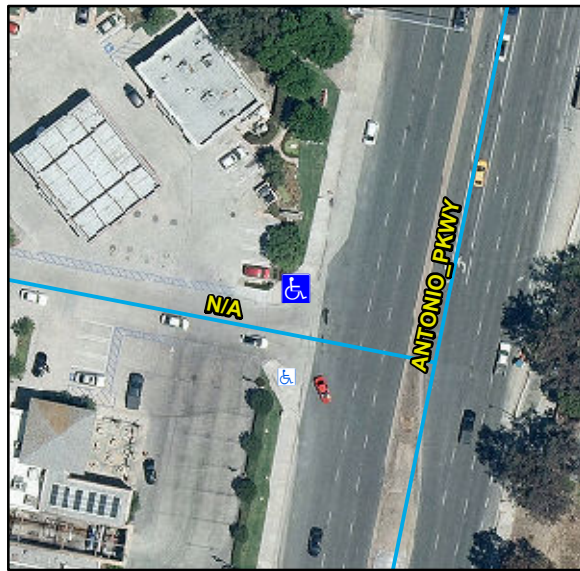
| Compliance | Description | Data | Compliance | Description | Data |
|---|---|---|---|---|---|
| N/A | Landing Movement Obstructed? | No | No | DWS Offset Left (in) | 5 |
| | Landing Movement Type | Curb | No | DWS Offset Right (in) | N/A |

### Possible Solutions:

Remove & Replace Detectable Warning System.

R305.2, STD 1115

Total Cost: \$ 800
