# Access Compliance Report Public Rights-of-Way (Curb Ramps)

Main Street: ANTONIO\_PKWY Cross Street: N/A Location: W

ADA ID: RPAT220208134246 Ramp Type: Type 4 - Parallel Initial Pass/Fail: Fail Overall Compliance: No Severity Score: 2

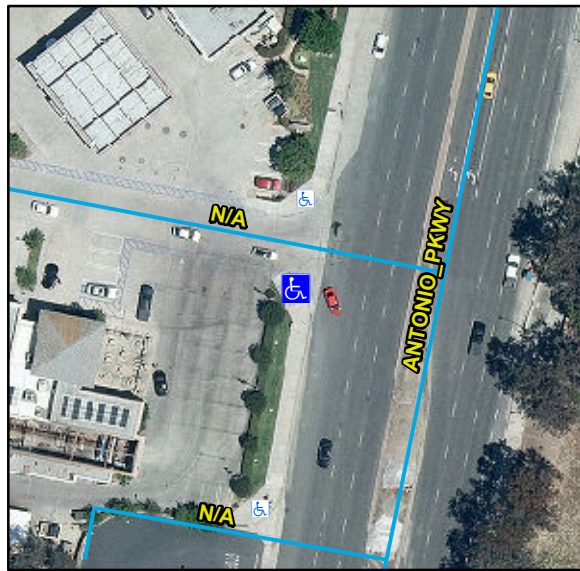
| Compliance | Description | Data | Compliance | Description | Data |
|---|---|---|---|---|---|
| Yes | Ramp Cross Slope LT (%) | 1.1 | No | Ramp Cross Slope RT (%) | 2.7 |

**Remove & Replace Curb Ramp With Two New Directional Ramps or Equivalent.**

**R304.5.3, STD 1115**
