# Access Compliance Report Public Rights-of-Way (Curb Ramps)

Main Street: N/A Cross Street: ANTONIO\_PKWY Location: NW

ADA ID: RPAT220208134518 Ramp Type: Type 1 - Perpendicular Diagonal Initial Pass/Fail: Fail Overall Compliance: No Severity Score: 16

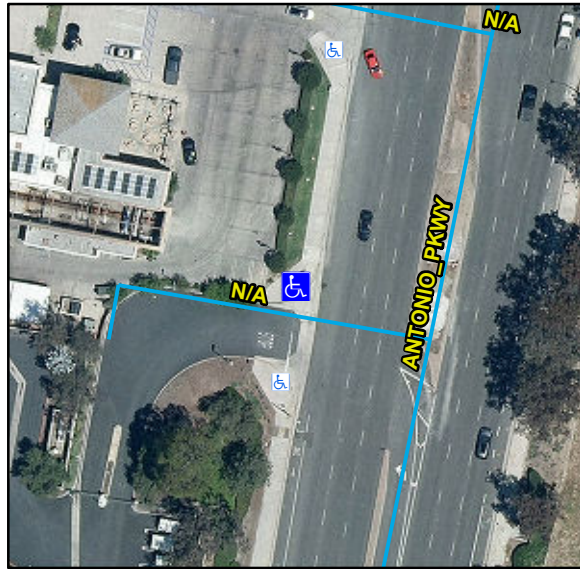
| Compliance | Description | Data | Compliance | Description | Data |
|---|---|---|---|---|---|
| No | Ramp Run Slope (%) | 8.9 | N/A | Flare Slope LT (%) | N/A |
| No | Ramp Cross Slope (%) | 4 | N/A | Flare Traversable LT | N/A |
| No | Gutter Lip Height (in) | 0.25 | | Road Run Slope (%) | 7 |

Remove & Replace Curb Ramp With Two New Directional Ramps or Equivalent.

R304.2.2, R204.3, R304.5.3, R302.7.2, STD 1115

Total Cost: \$ 6160
