# Access Compliance Report Public Rights-of-Way (Curb Ramps)

Main Street: ANTONIO\_PKWY Cross Street: N/A Location: W

ADA ID: RPAT220208134718 Ramp Type: Type 1 - Perpendicular Diagonal Initial Pass/Fail: Fail Overall Compliance: No Severity Score: 30

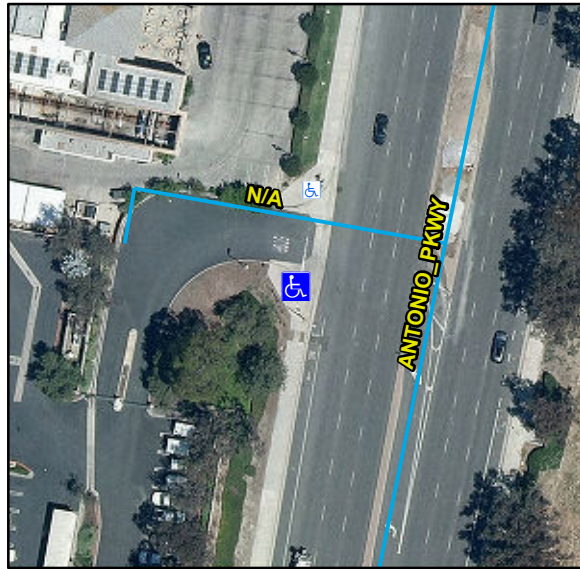
| Compliance | Description | Data | Compliance | Description | Data |
|---|---|---|---|---|---|
| No | Ramp Run Slope (%) | 12.5 | N/A | Flare Slope LT (%) | N/A |

**Remove & Replace Curb Ramp With Two New Directional Ramps or Equivalent.**

**R304.2.2, R204.3, STD 1115**
