# Access Compliance Report Public Rights-of-Way (Curb Ramps)

Main Street: N/A Cross Street: ANTONIO\_PKWY Location: W

ADA ID: RPAT220208134951 Ramp Type: Type 1 - Perpendicular Diagonal Initial Pass/Fail: Fail Overall Compliance: No Severity Score: 15

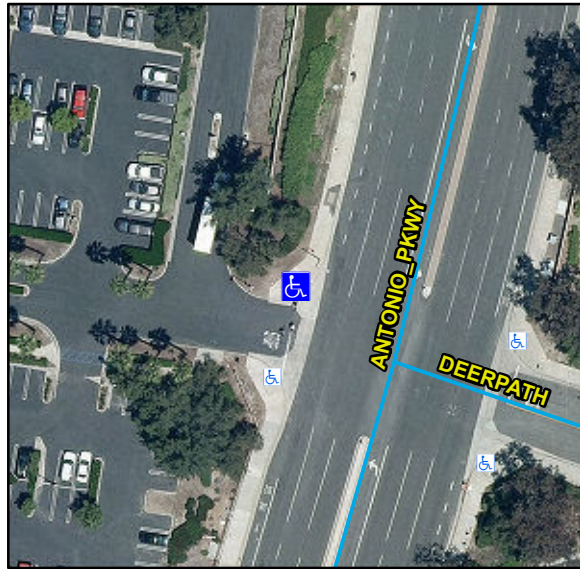
| Compliance | Description | Data | Compliance | Description | Data |
|---|---|---|---|---|---|
| No | Ramp Cross Slope (%) | 6.3 | N/A | Flare Traversable LT | N/A |
| No | Gutter Lip Height (in) | 0.25 | | Road Run Slope (%) | 8 |

Remove & Replace Curb Ramp With Two New Directional Ramps or Equivalent.
